Agenda RICHLAND PLANNING COMMISSION MEETING NO. 6-2013

1. APPLICANT: ROCKWORTH COMPANIES (M2013-104)*

Request: APPROVAL OF SITE PLAN TO CONSTRUCT A 252 UNIT APARTMENT

Wetland Delineation Report

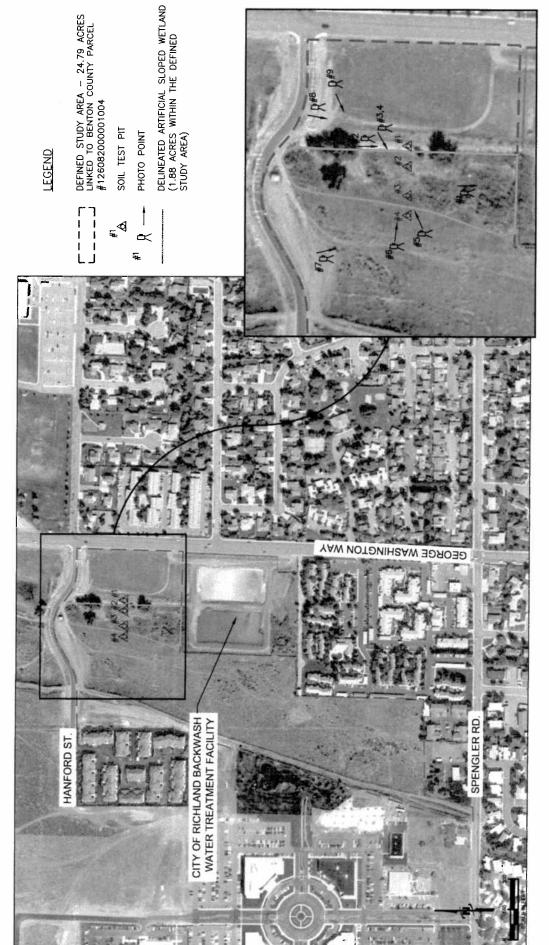
BENTON COUNTY PARCEL #126082000001004 2555 GEORGE WASHINGTON WAY WETLAND DELINEATION MAP

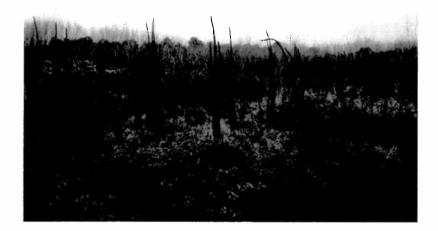
Photo 1: Looking southerly toward the dike associated with the adjacent backwash settling detention ponds.

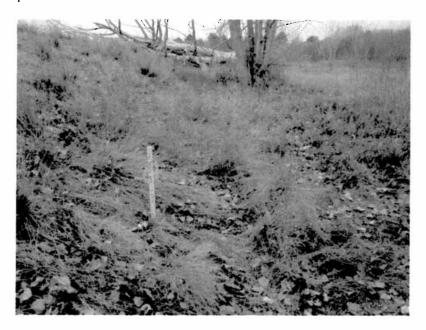
Photo 2: Soil test pit (STP) #1 (which is paired with STP #2) is located in the upland area on the eastern edge of the delineated wetland area. Vegetation in this area consisted primarily of cheat grass and crested wheatgrass. The orange pins represent the wetland boundary.

This data point is located along the western toe of the fill slope covering the 10" outfall pipe, which is situated near the eastern edge of the identified wetland area. The established transect is located midway between Hanford Street and the northern common property boundary shared with the settling basins. A facultative upland vegetative community is present at this STP. Indications of hydric soils and wetland hydrology were not observed. None of the three parameters were met, making this STP an upland data point.

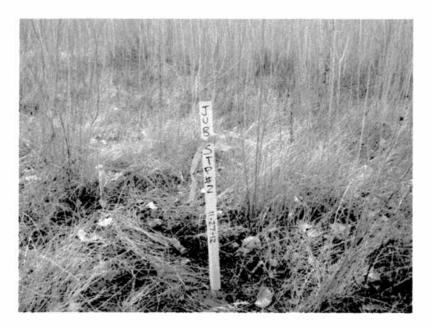
Photo 3: STP #2 located to the west of STP #1 within the delineated wetland area. Vegetative assemblages in this area were dominated by coyote willow, but also contained facultative bunch grasses.

This data point, which is paired with STP #1, is located 52 feet directly west of STP #1. It is located within the shallow depression north of the western settling pond. A hydrophytic vegetative community consisting primarily of coyote willow was present at this STP. Hydric soils were indicated by a depleted matrix. Wetland hydrology was lacking; the STP was dry to a depth of 24 inches. It should be noted that the settling ponds, that are suspected to provide subsurface water to this area via lateral seepage, were dry at the time of observation. Based on the vegetative community and soils encountered, wetland hydrology is believed to be present at this STP when the ponds are in use (i.e. full of water). STP #2 can be considered a wetland point, since wetland hydrology via lateral seepage was assumed.

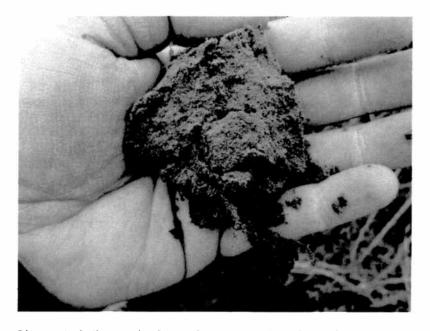
Photo 4: Soil sample from the upper 12 inches of STP #2. Mottling is visible in this photo, indicating hydric soils are present.

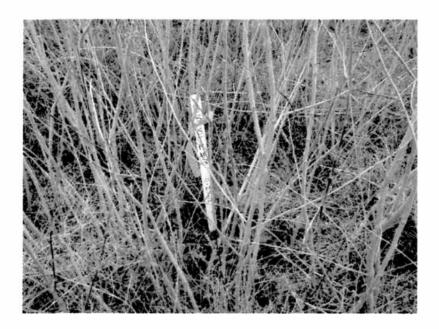
Photo 5: STP #3 located to the west of STP #2 within the delineated wetland area. Similar to STP #2, the vegetation was dominated by coyote willow at STP #3, however, the facultative bunch grasses present at STP #2 were not present at STP #3. The herbaceous stratum was instead dominated by a small relative percentage of Baltic rush.

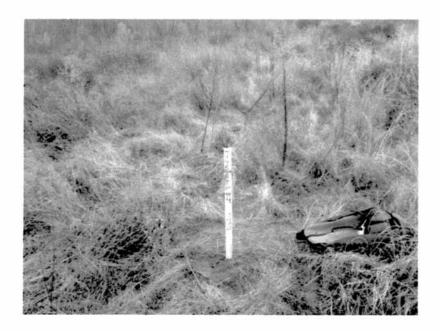
Photo 6: STP #4 (upland) is located beyond the western edge of the delineated wetland area, west of STP #3. A facultative upland vegetative community was present in this area.

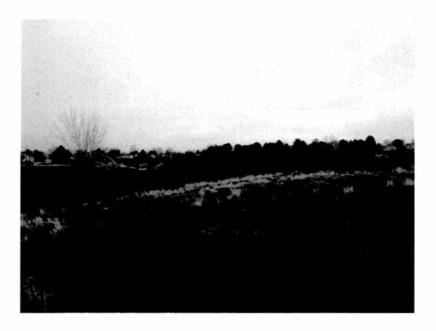
Photo 7: Looking south easterly at the delineated wetland area that correlates to the edge of the coyote willows.

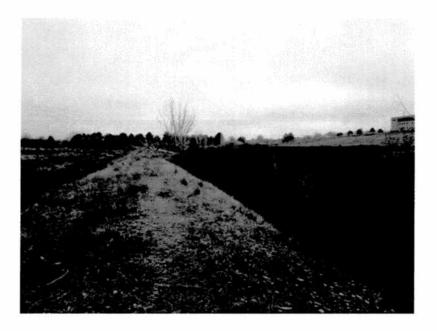
Photo 8: This photo is looking southerly along the earthen berm that covers the 10" outfall pipe. The wetland boundary extends immediately west of the western toe of this earthen berm.

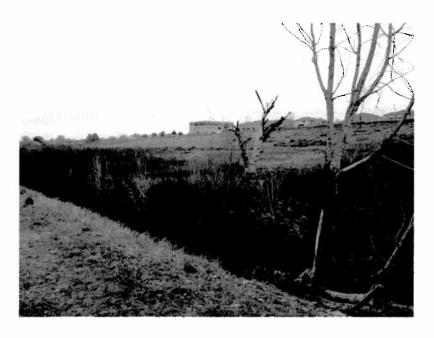
Photo 9: Looking southwest at the identified wetland area from the top of the earthen berm. The charred snags are cottonwoods.
